**Flood Control Project Maintenance  
Levee Inspections**

**Fall 2014 Levee Maintenance Deficiency Summary Report**

**Reclamation District No. 0551 Pearson**

**Levee Inspection Report By Mile - Fall 2014**

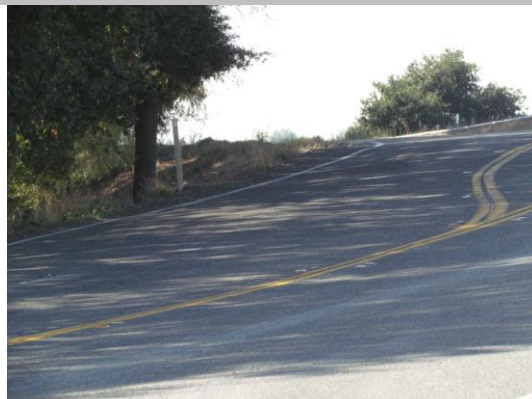
Photo 1 of 1 : FA\_2014\_RD0551\_175\_25\_20141107\_00016.jpg

LM Start	0.00	Rating **	A	Issue No.	25
LM End	6.84	Issue Type +	Ma	Location *	LS
Category	Earthen Levee			GPS Latitude/Longitude	
				Start	End
Item	Vegetation			38.336458 °	38.258904 °
				-121.564751 °	-121.517904 °
DWR ID	DWR_RD0551_01_f_2014_25				
Action/Comments					
Control annual grass and weeds on the levee slopes and easements. Inspector Comments: The District has the goats go through and remove the vegetation from the levee slope, from 0.00 to 6.78. Good job.

Looking downstream from levee mile 0.00 landside slope.

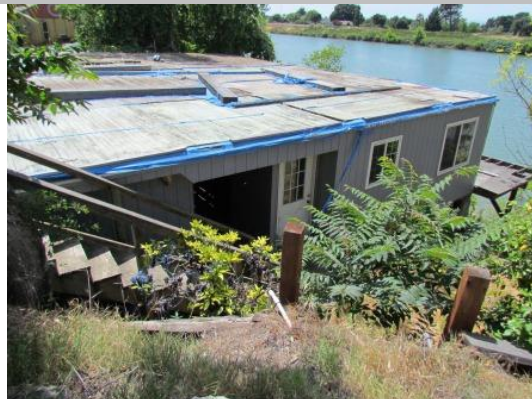
Photo 2 of 2 : FA\_2014\_RD0551\_175\_21\_20141008\_00002.jpg

LM Start	0.50	Rating **	U	Issue No.	21 (cont)
LM End	0.50	Issue Type +	En	Location *	WS
Category	Earthen Levee			GPS Latitude/Longitude	
				Start	End
Item	Encroachments			38.331158 °	38.331158 °
				-121.570751 °	-121.570751 °
DWR ID	DWR_RD0551_01_s_2014_21				
Action/Comments					
Building Inspector Comments: The new land owner is working with the LMA trying to get CVFPB Permits for this project, this is the 2nd year in process.

Building and steps waterward. Photo taken 01-04-2014.

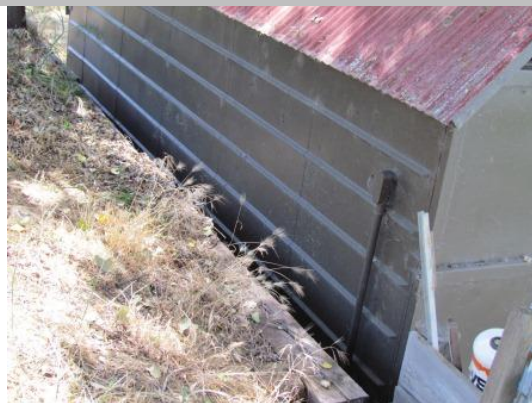
Photo 1 of 1 : FA\_2014\_RD0551\_175\_87\_20141008\_00003.jpg

LM Start	0.60	Rating **	U	Issue No.	87
LM End	0.60	Issue Type +	En	Location *	WS
Category	Earthen Levee			GPS Latitude/Longitude	
				Start	End
Item	Encroachments			38.329895 °	38.329895 °
				-121.571840 °	-121.571840 °
DWR ID	DWR_RD0551_01_s_2012_87				
Action/Comments					
Retaining Wall					
Inspector Comments: At this location the new land owner has placed a railroad tie retaining wall against the bank adjacent to the metal building. Discovered during the spring inspection. 3-27-2013. District is working with landowner to get CVFPB permit. No new information for the Fall 2014 inspection.

This unauthorized retaining wall remains. Photo taken 01-04-2014. No photo taken during Fall 2014 inspection.
